Ellon WWTW

November 2022 incident

Investigation

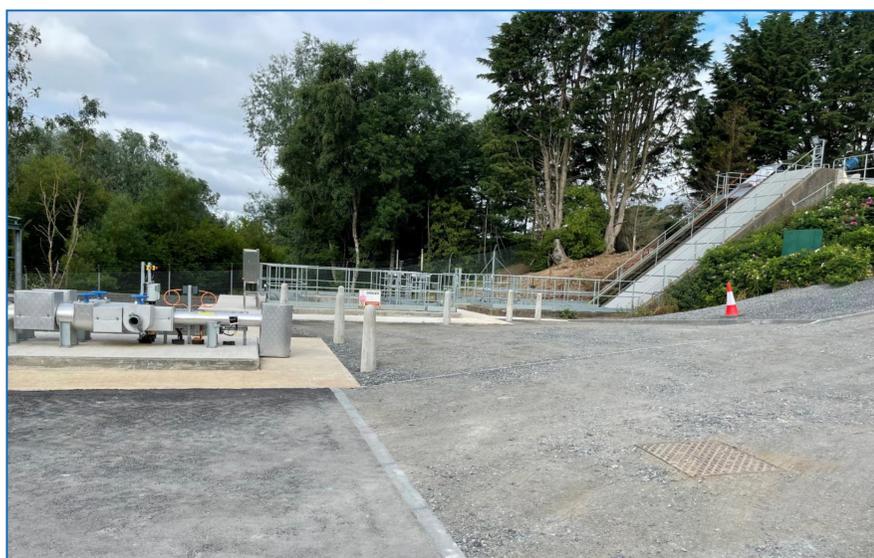
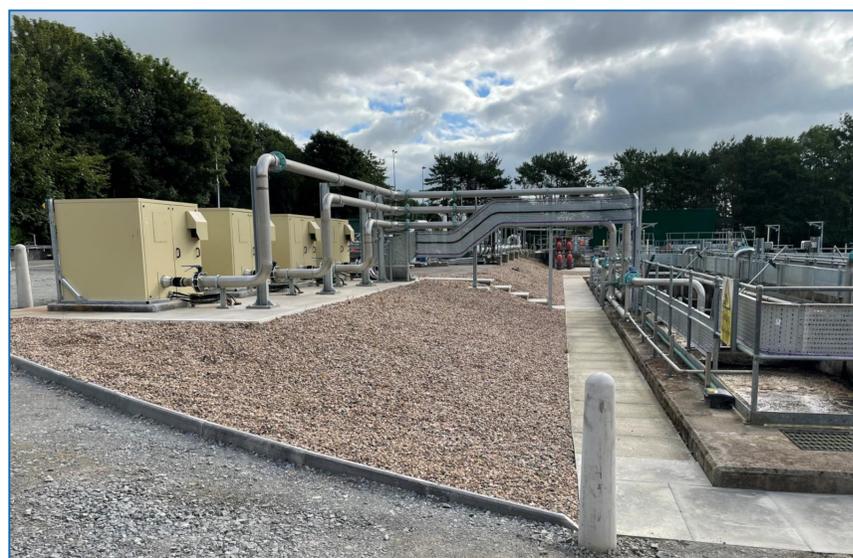
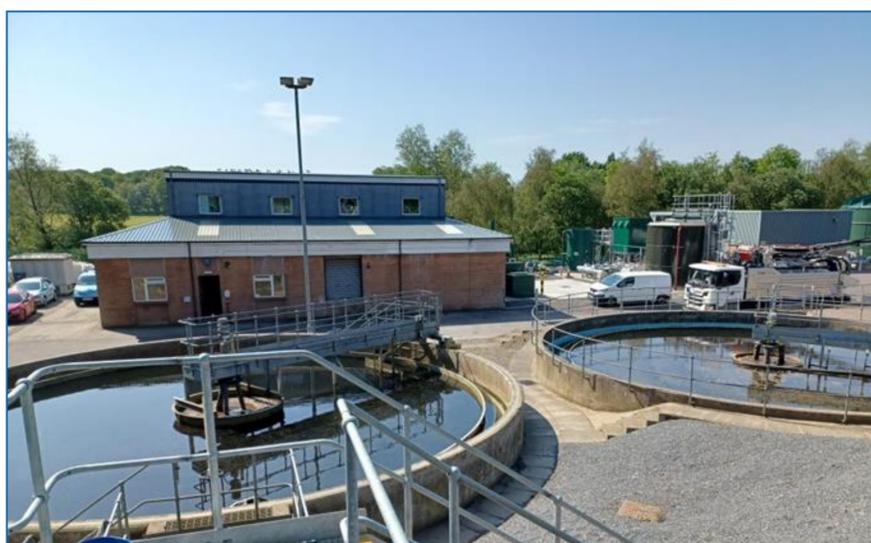
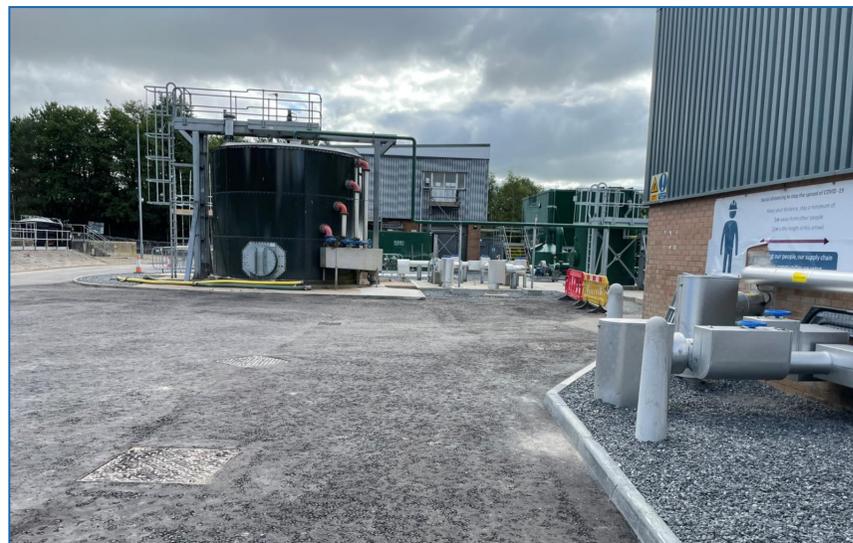
- Ellon Waste Water Treatment Works following its upgrade in May 2022. Clockwise from top-left: screw pumps which lift incoming waste water to the top of the site; blowers which oxygenate the site's aeration lanes; tanks store sludge for collection; the site's Final Settlement Tanks.

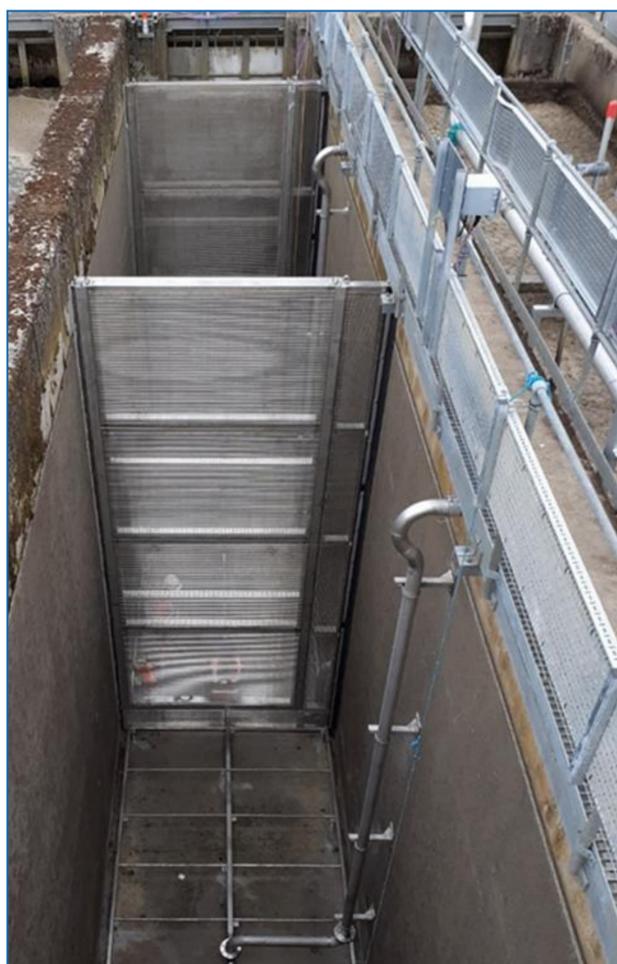
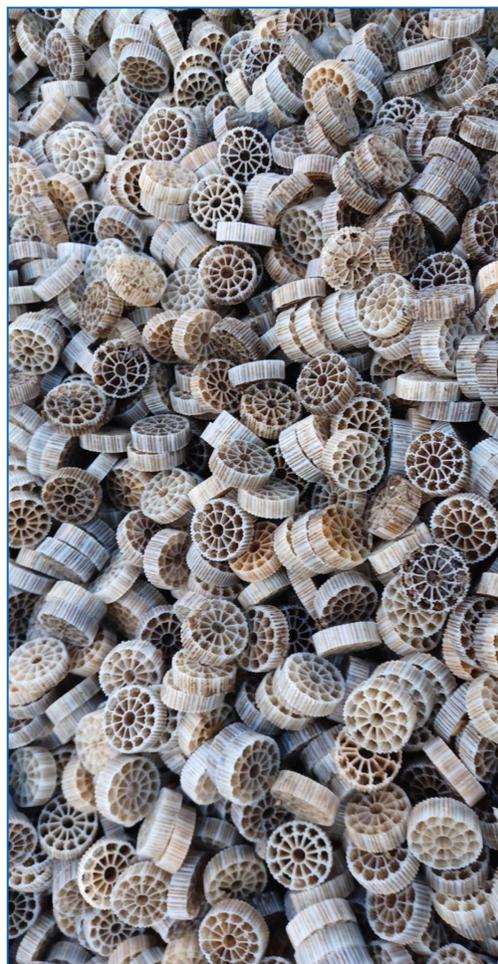
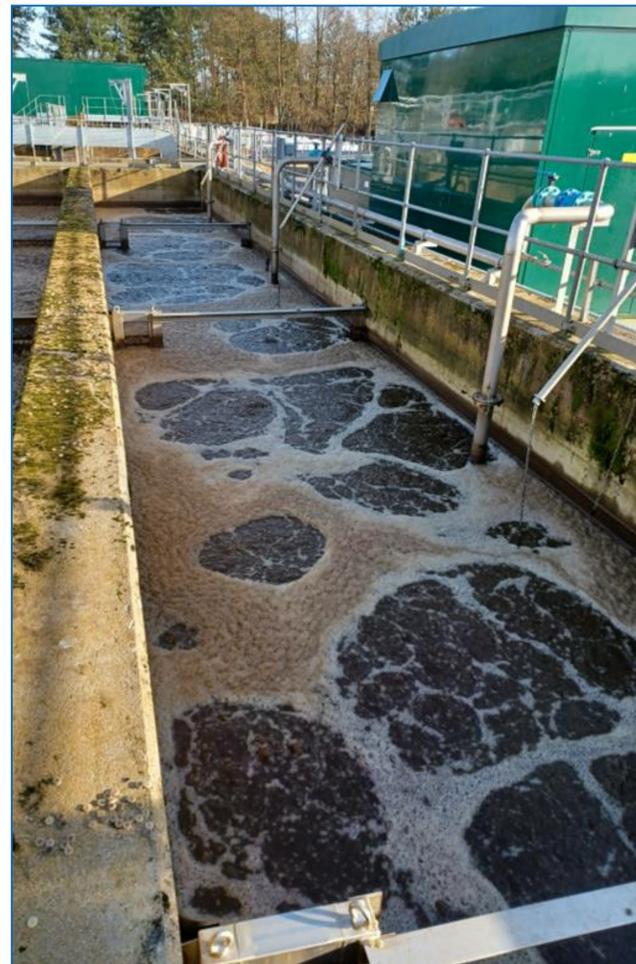
- Left: the deep aeration lanes and the screens which divide them into cells before entering operation. Middle: the plastic biofilters which are associated with the IFAS technology and host communities of bacteria to rapidly break down nutrients in the waste water. Right: the IFAS aeration lanes in operation.

Small plastic bio-filters, designed to increase the surface area on which 'good' bacteria can grow, are suspended in the aeration lanes. In this oxygen-rich environment, these bacteria play a key role in breaking down the nutrients in waste water so that it can be safely returned to the environment.

There was an initial fault affecting the IFAS aeration lanes on 12th November, when blowers within the tanks shut down due to a problem. This resulted in biofilters blinding the screens within the tanks, some of which overtopped the screens and entered the Final Settlement Tanks.

3. **Blinding of mesh screens:** Screens between cells within the aeration lanes were partially blinded, causing water levels to increase on the upstream side. During very wet weather conditions, this could have caused screens to overtop, with buoyant media then bypassing the screens that are designed to retain them.

2. **Foaming:** Plans are in place to ensure that any foaming problems can be managed, with the option to add an antifoam chemical if it is needed.
3. **Replacement of screens:** Construction work to replace the screens within the aeration lanes is now complete. The screens have been replaced with taller screens, including larger mesh which would retain media but be less susceptible to blinding and over-topping. Arrangements have been made to ensure the screens can be cleaned safely.

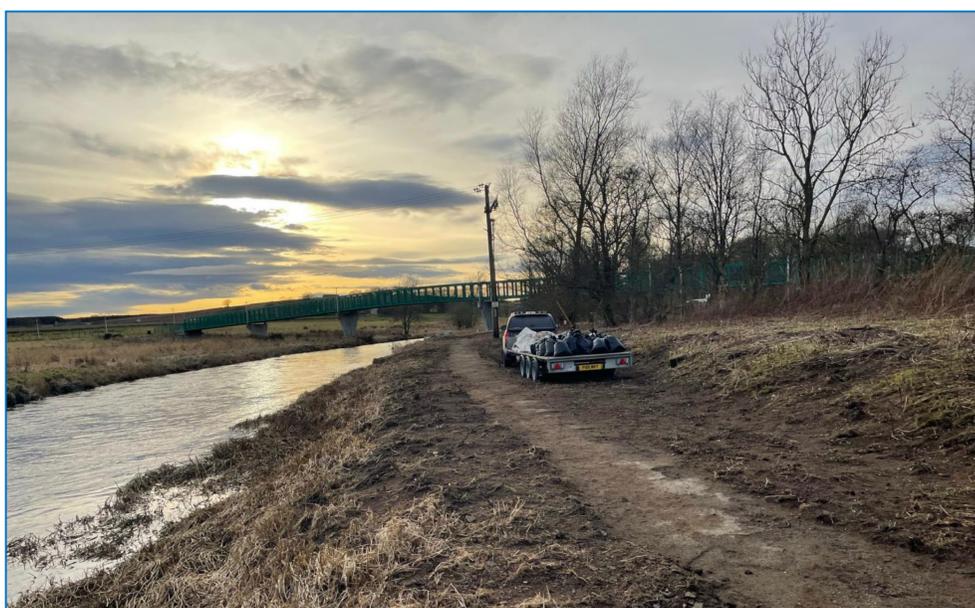
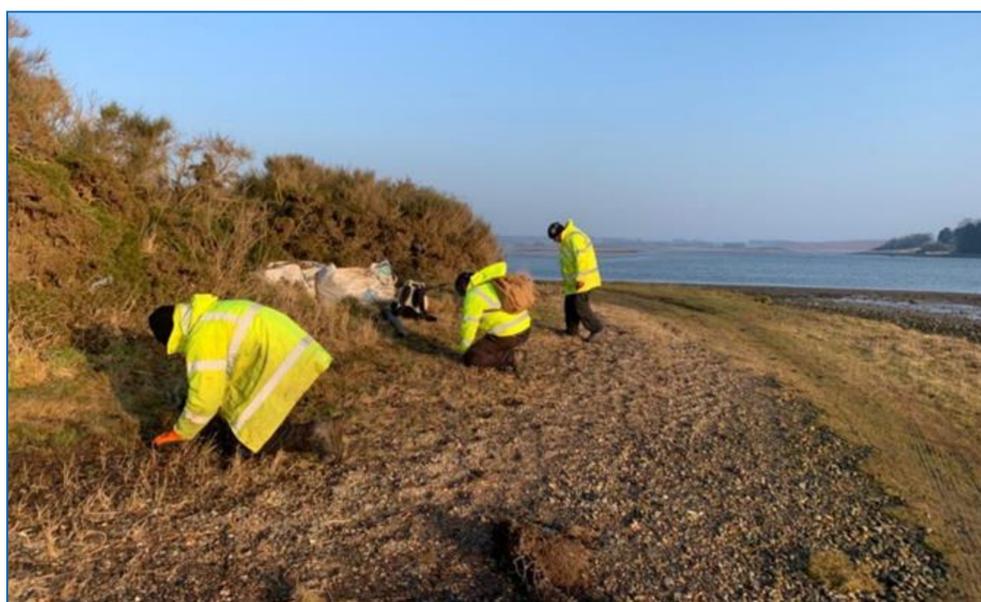
- Locations covered by clean-ups carried out by Scottish Water and our supply chain partners have included Newburgh Beach, the banks of the River Ythan, Forvie Nature Reserve, Forvie Beach and Balmedie Beach. Significant work was also needed within the WWTW to remove the biofilters from the process and ensure the site could continue to serve the local community without risk of recurrence.

Clean-up activity has varied from the use of tractors and chain rakes in the weeks following the incident, to maximise recovery of filters from local beaches at low tide, to much slower work by hand in environmentally sensitive locations around the Ythan Estuary.

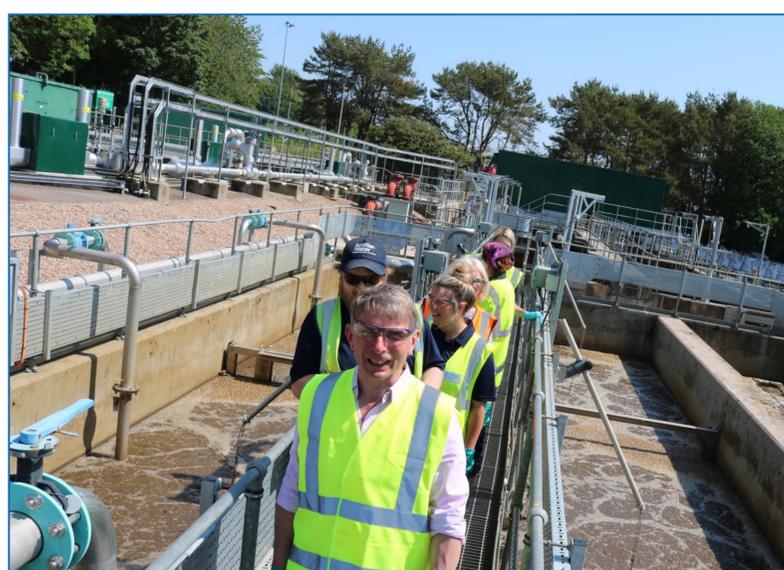
- Stakeholders seeing the aeration lanes operating without IFAS media and receiving an update during a site visit in June 2023.
